Shoreline change in Cuddalore district, Tamil Nadu (2008 and 2018)

Map description and analysis

Topic: Shoreline Change

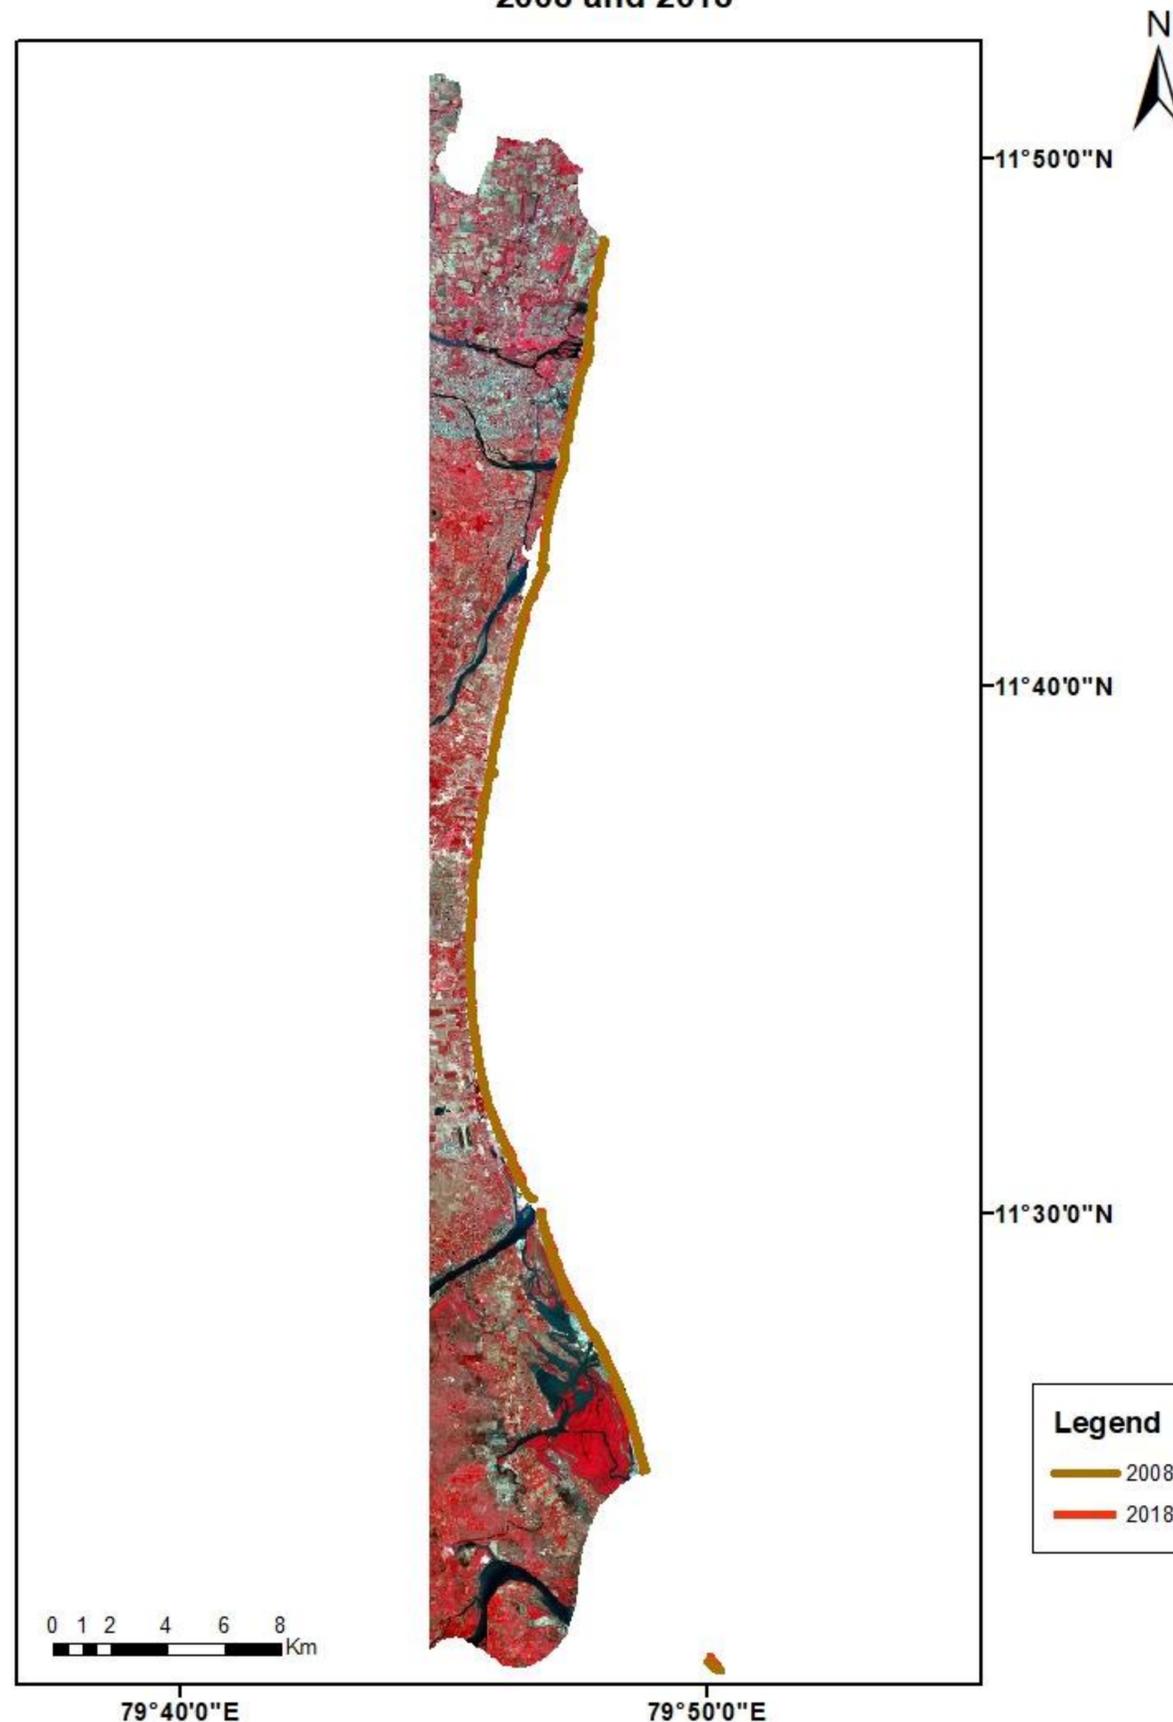
Shoreline change in cuddalore district
2008 and 2018

Cuddalore has always been classified as a multi-hazard prone district. Cyclones and floods have wreaked havoc in the District several times in the past few centuries. For this map two years are considered to monitor the shoreline changes i.e 2008 and 2018.

YEAR	Length (m)
2008	53318.4
2018	53031.97

Data	Year	Resolution
LISS III	2008,2018	23.5m

Using LISS III data for creation of vector layer (line,shp) for 2009 and 2018 . Use the shoreline obtained from the LISS III data,

The Cuddalore district is divided into three coastal regions: Cuddalore, Port Novo and Chidambaram. The coastal region of Cuddalore has been affected by many coastal hazards such as tsunami, thane cyclone etc. These hazards have affected the shoreline of the area. This map will help to analyze the erosion and accretion rate of the coast. This in turn will help to understand the coastal vulnerability of the Cuddalore district.
